Periprosthetic fracture caused by stress shielding after implantation of a femoral condyle endoprosthesis in a transfemoral amputee—a case report

Tina S Wik^{1,2}, Olav A Foss¹, Steinar Havik¹, Leif Persen¹, Arild Aamodt^{1,2}, and Eivind Witsø^{1,2}

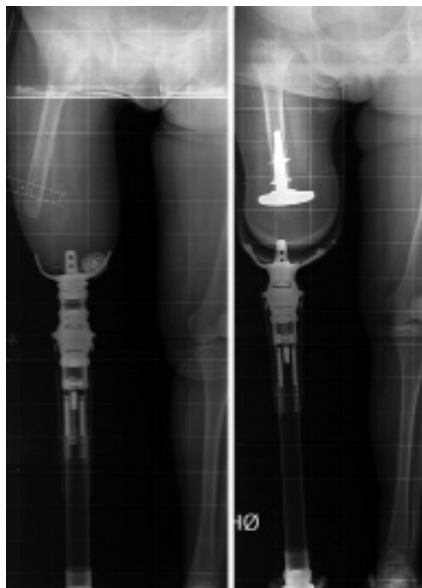
Figure 2. Femoral alignment before and after insertion of the FCE.
